The

Safety

Wire

July 2021

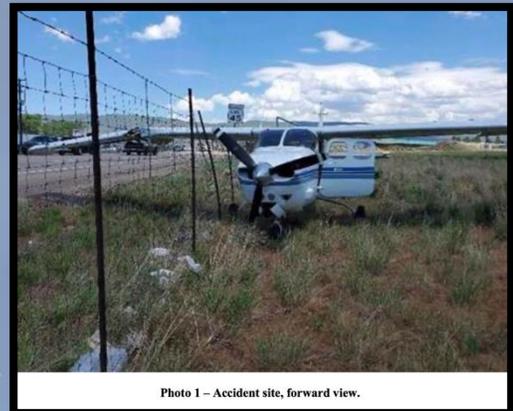
The pilot reported that after completing the descent/approach checklist, he turned on the auxiliary fuel pump and switched from the left fuel tank to the right fuel tank. While on final approach, the pilot reported that he neglected to turn off the auxiliary fuel pump. When he made a slight power reduction, the engine flooded and lost power. The airplane subsequently touched down in the grass short of and to the right of the runway. During the landing roll, the right wing collided with a fence pole. The right wing was substantially damaged.

The manufacturer's before landing checklist requires the auxiliary fuel pump in the 'OFF' position during landing. A caution follows: "Failure to turn the auxiliary fuel pump off may result in a complete power loss at reduced throttle settings due to an excessively rich mixture." The pilot reported that he had modified the before landing checklist which omitted the fuel pump switch position.

Photo 1 – Accident site, forward view.

The National Transportation Safety Board determines the probable cause(s) of this accident to be: The pilot's failure to switch the fuel pump to the 'OFF' position during landing, resulting in a loss of engine power and subsequent collision with a fence during landing. Contributing to the accident was a modified before landing checklist which omitted the fuel pump switch position.
