**SUBJ:** Fuselage Cracks

This Special Airworthiness Information Bulletin informs owners and operators of Bell Helicopter Textron Canada Limited (Bell) Model 206L helicopters about reports of fuselage cracking and possible loose rivets in an area that currently has no inspection program.

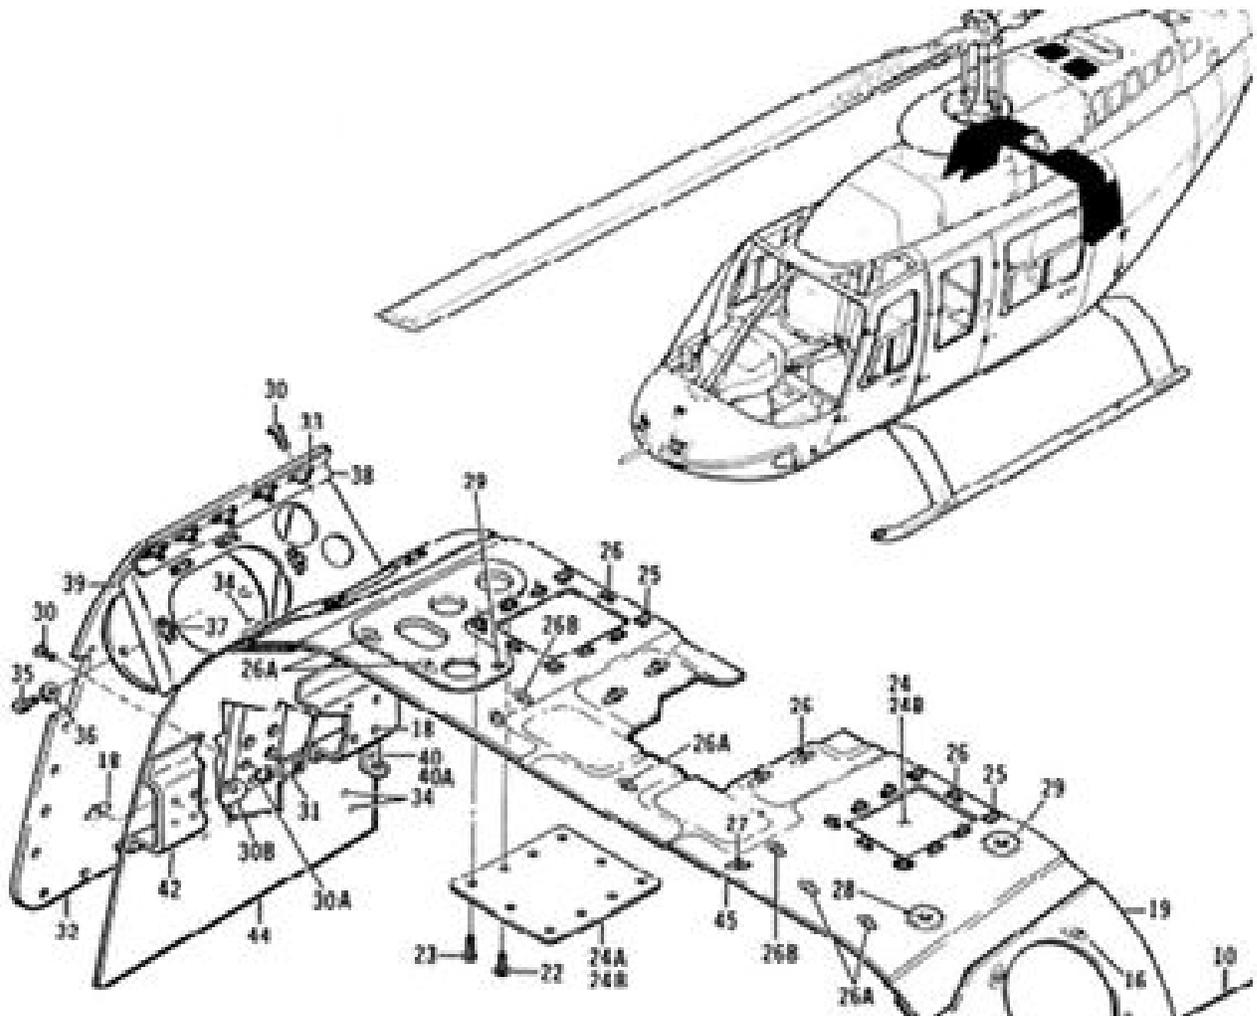
During parts of the progressive inspection, opening of the door assemblies identified in Figure 1 (items 24, 24A, and 24B) is required to inspect the most aft hardware of the pylon support assemblies for the transmission and the forward engine mount fuselage structure. However, there are currently no specific Service Bulletins or Notices to inspect this area. Access to conduct a thorough inspection can also be limited by the size of the opening. The Bell 206L Maintenance Manual and Structural Repair Manual do not include specific damage assessment criteria or repairs for this area. Transport Canada has issued Civil Aviation Safety Alerts(CASA) No. 2019-05 to raise awareness of a potential crack in the fuselage frame/bulkhead going undetected during a scheduled maintenance inspection. The CASA is available at <https://www.tc.gc.ca/eng/civilaviation/opssvs/cracks-fuselage.html>.

1. Each time the left and right hand door assemblies identified in Figure 1 (items 24, 24A, and 24B) of this SAIB are removed, inspect the entire internal structure of FS 142.7 to FS 155.00 for smoking and working rivets and for cracks. For areas with limited access, the use of a mirror and flashlight as an aid in the visual inspection is recommended. A borescope could also be used.
2. Use the approved Bell Maintenance and Structural Repair Manuals (SRM) for inspecting, repairing and the replacing defective parts that are within the scope of authorized maintenance.
3. For any repairs not included in the SRM, repair in accordance with any FAA approved repair.
