**SAIB:** SW-18-13  
**Date:** April 30, 2018

**SUBJ:** Main Transmission Plate Fitting

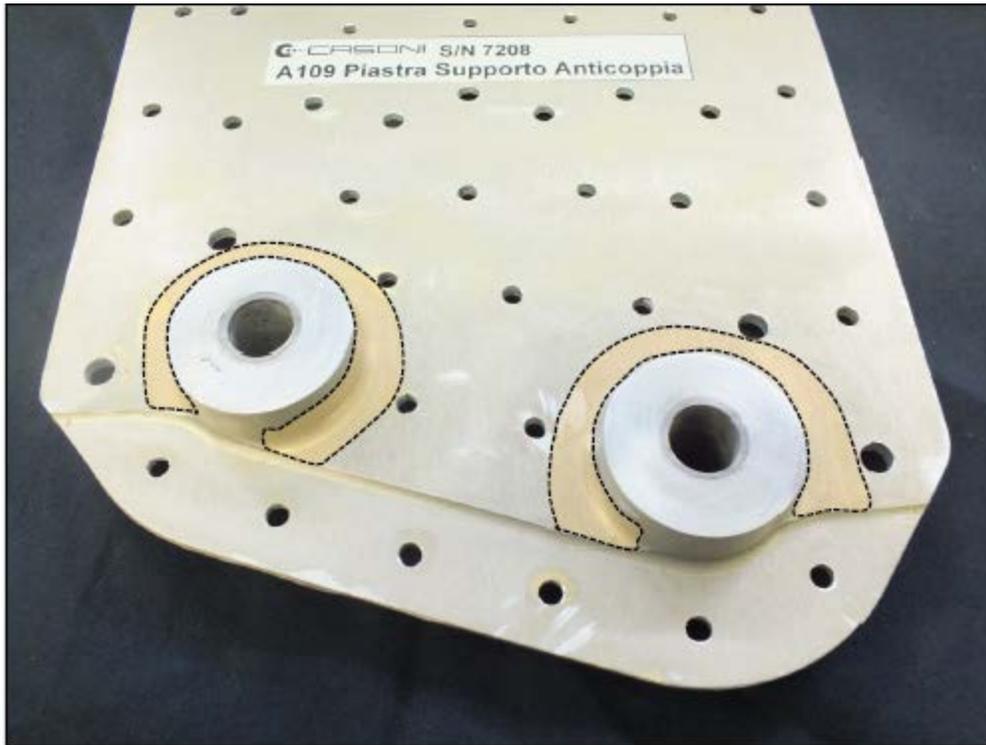
Figure 1

An operator reported several cases of cracks in the fitting and loose fasteners (Hi-Loks) on their fleet of AW119 MKII helicopters. The FAA's Rotorcraft Standards Branch queried our Monitor Safety Analyze Data (MSAD) and Service Difficulty Reports (SDR) databases and found that there were twelve occurrences of cracked fittings. Because they are the state of design for these model helicopters, we contacted the European Aviation Safety Agency (EASA). EASA performed a safety assessment with input from Agusta and determined there is not an unsafe condition that warrants mandatory action. On March 6, 2018, Agusta issued Service Bulletin No. 119-087 to conduct an eddy current inspection of the plate for cracks. Although the safety assessments concluded that AD action is not currently warranted, we are requesting information to determine if future AD action is warranted. This SAIB includes models other than the AW119 MKII helicopters because they use the same P/N fitting.

- Inspect the left and right fitting for a crack and loose Hi-Lok fasteners within 100 hours time-in-service (TIS). The areas to be inspected are depicted in the following Figure 1:

Note: Do not use any tools to inspect for loose fasteners. An operator reported they were able to turn the Hi-Lok by hand.

- If there is a crack, replace the fitting before further flight.
- If there are loose fasteners, replace them before further flight.
- Provide the following information within 10 days after the inspection to the individual listed in the For Further Information Contact paragraph:
  - a. Aircraft model and serial number,
  - b. Hours TIS since the fitting was installed,
  - c. Location and extent of any crack.
  - d. Any loose fasteners in the area.
