SUBJ: Exhaust Turbocharger; V-band Couplings Used in Exhaust Systems on Turbocharged Reciprocating Engine Powered Aircraft **SAIB:** CE-18-07
Date: December 14, 2017

Introduction

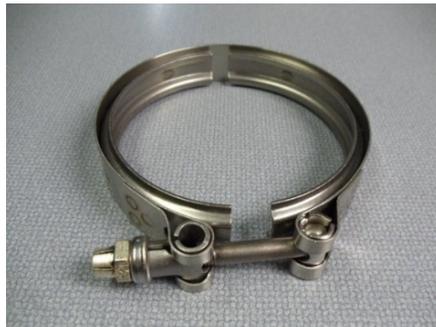
2 segment, coupling, new

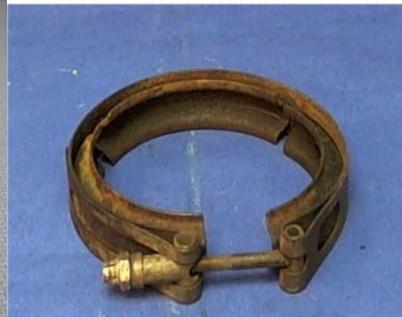
3 segment, coupling removed from service

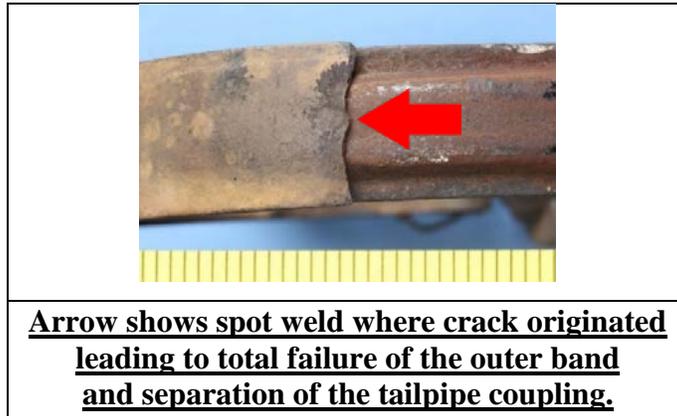
Reference: turbocharger to tailpipe interface

The FAA is aware of three recent accidents/incidents, involving cracked and/or separated multi-segment, spot welded, v-band couplings, which resulted in four fatalities. The failed and cracked v-band couplings pictured below are from the accident/incidents noted above.

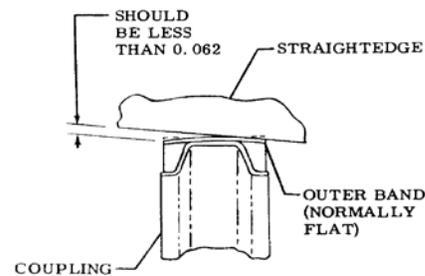
1. The FAA recommends at the next scheduled inspection and at each annual or 100-hour inspection thereafter that you perform a detailed visual inspection of the turbocharger exhaust v-band coupling(s) for signs of:
 - a. Cracks in the coupling outer band (flat) material, primarily at or near a spot-weld.
 - b. Cupping or bowing of the coupling outer band beyond 0.062 inches in depth as shown below.

If any of the above conditions are found, the v-band coupling is considered unairworthy and should be removed and replaced before further flight with a new, zero time in service (TIS), FAA-approved coupling according to the instructions and procedures found in the airframe or engine ICA's, as applicable. All v-band couplings removed from service should be permanently destroyed and not used on any other aircraft or aircraft application.

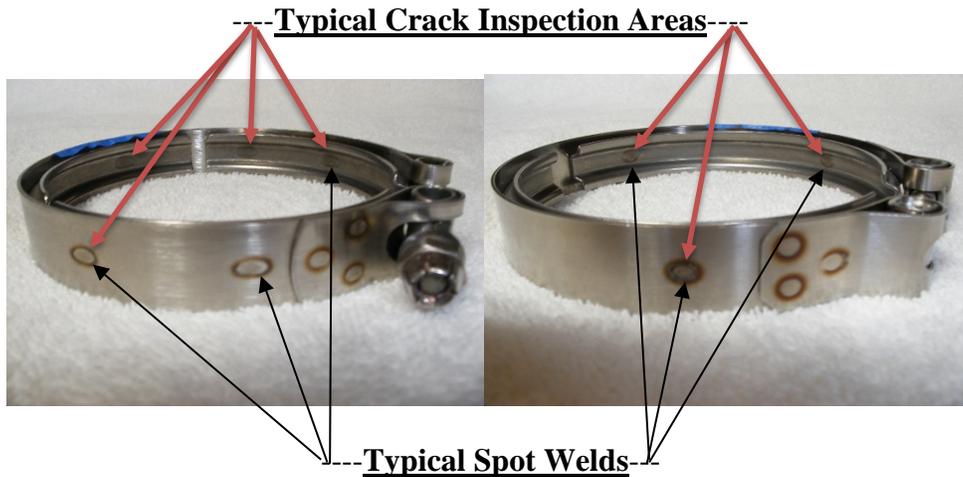
- c. Cracks in the coupling v-retainer segment interior or exterior surface, e.g. at bend radii.
- d. Looseness, separation of the outer band to v-retainer segment(s) at any spot-weld.
- e. Gaps between the v-retainer segments and the outer band at or between spot-welds.
- f. Corrosion that is not easily removed from any component of the coupling.
- g. Deformity, including but not limited to, out of round, twisted, re-formed by any method.
- h. Physical damage, including but not limited to, cracks, gouges, tears, bulges, fractures.
- i. Repairs or any indications of past repairs, as no repair process is known to be effective.
