The

Safety

Wire

November 2016

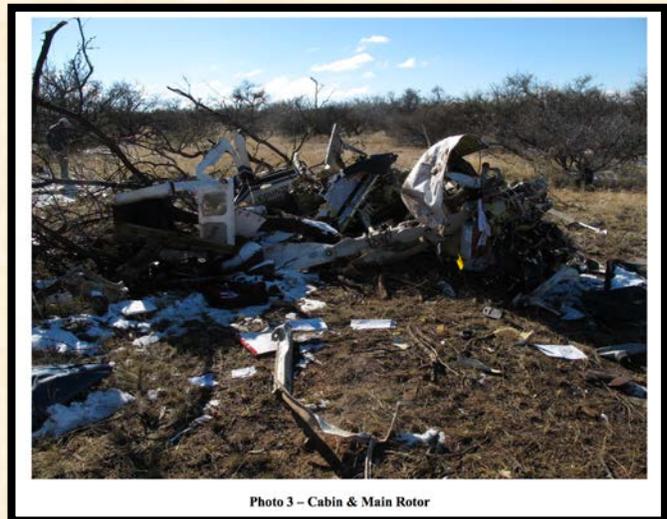
Photo 3 – Cabin & Main Rotor

On December 31st, 2014, the helicopter was on a visual flight rules (VFR) repositioning flight in preparation for providing contracted air support capability to the local sheriff's office the next day. The operator reported that the helicopter did not arrive at the intended destination, and the wreckage was located 29 miles north of the intended destination. The helicopter was fragmented into multiple pieces along a 174-ft debris path. Ground scars and wreckage distribution were consistent with collision with terrain while in forward flight. The observations from a weather station located 3 miles east-southeast of the accident site indicated ceilings less than 500ft and visibility less than 1 mile were likely at the time of the accident. The relative humidity had rapidly increased above 90 percent immediately before the accident, which would be indicative of cloud cover and mist at or near the surface. Witnesses living in the local area reported that the visibility at ground level was very limited, with low clouds and fog. Observations near the destination showed lowered visibility and low ceilings as the rain moved eastward through the accident area. Gusty winds ahead of the lowering ceilings would have likely created low-level wind shear.

The National Transportation Safety Board determines the probable cause(s) of this accident as follows: The pilot's continued visual flight into instrument meteorological conditions, which resulted in an inflight collision with terrain. Contributing to the accident was the pilot's inadequate preflight planning, during which he failed to identify forecasted deteriorating weather conditions along the route of flight.
