The

Safety

Wire

January 2018

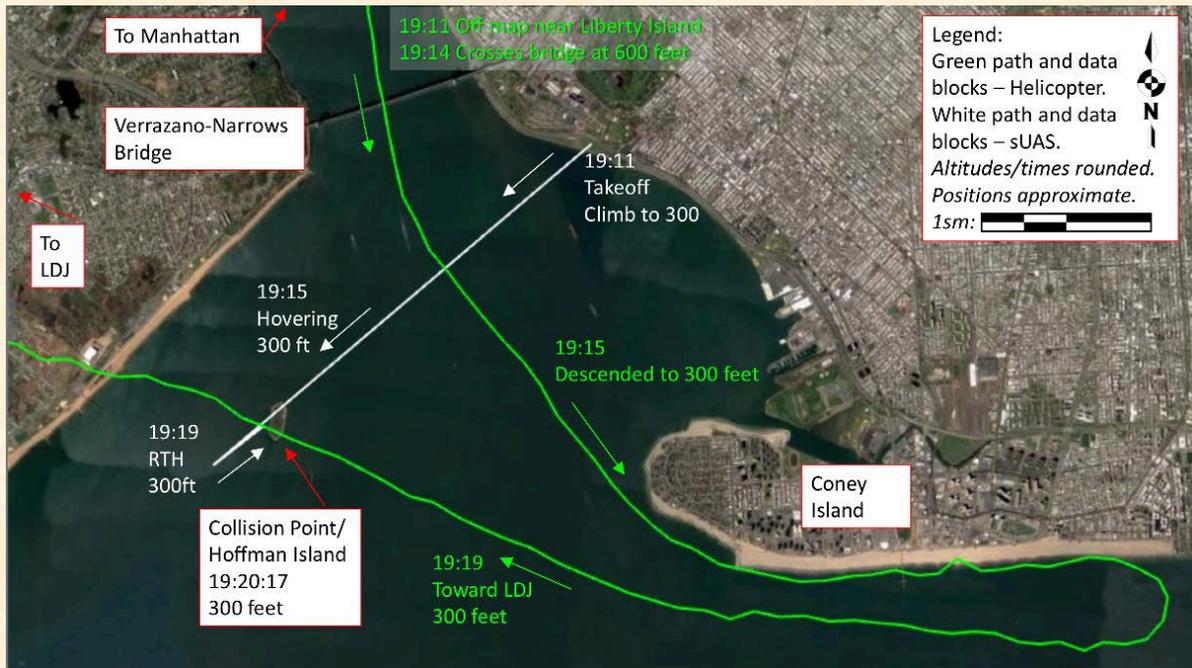
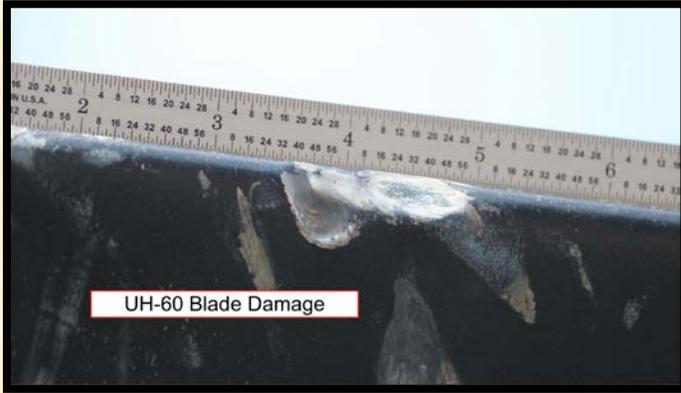
Aircraft:	UH-60M and DJI Phantom 4
Injuries:	None
NTSB#:	ERA16FA248

The United States Army UH-60M helicopter was operating under visual flight rules within Class G airspace about 300ft above mean sea level (MSL) when it collided with a privately owned and operated DJI Phantom 4 small unmanned aircraft system (sUAS). The helicopter sustained minor damage and landed uneventfully; the sUAS was destroyed. Although the pilot flying the helicopter saw the sUAS before impact and immediately applied flight control inputs, there was insufficient time to avoid the collision.

During the incident flight, the pilot of the sUAS intentionally flew the aircraft 2.5 miles away, well beyond visual line of sight and was just referencing the map on his tablet; therefore, he was not aware that the helicopter was in close proximity to the sUAS. Although the pilot stated that he knew that the sUAS should be operated at an altitude below 400 ft, flight logs revealed that he had conducted a flight earlier on the evening of the incident, in which he exceeded 547 ft altitude at a distance of 1.8 miles, which was unlikely to be within visual line of sight. In addition, even though the sUAS pilot indicated that he knew there were frequently helicopters in the area, he still elected to fly his sUAS beyond visual line of sight, demonstrating his lack of understanding of the potential hazard of collision with other aircraft. In his interview, the sUAS pilot indicated that he was not concerned with flying beyond visual line of sight, and he expressed only a general cursory awareness of regulations and good operating practices.

A Temporary Flight Restriction (TFR) was in effect for the area of the flight; the helicopter was authorized for flight within this area. The helicopter was operating over water and not in the vicinity of any vessels; therefore, its operating altitude was in accordance with FAA regulations and Army guidance. The sUAS pilot was unaware of the active TFRs in the area that specifically prohibited both model aircraft and UAS flight. Further, the sUAS pilot relied only on the DJI GO4 app for airspace awareness. Although the TFR airspace awareness functionality in the DJI app (GEO) was not active at the time of the incident, this feature is intended for advisory use only, and sUAS pilots are responsible at all times to comply with FAA airspace restrictions. Sole reliance on advisory functions of a non-certified app is not sufficient to ensure that correct airspace information is obtained. Had the functionality been active, the sUAS pilot would still have needed to connect his tablet to the internet before the flight in order to receive the TFR information. Since the sUAS pilot's tablet did not have cellular connection capability, it is unlikely that he would have been able to obtain TFR information at the time of the flight. Because the pilot solely relied on the app to provide airspace restriction information; he was unaware of other, more reliable methods to maintain awareness.

The collision occurred 2 minutes before the end of civil twilight. Although modeler (recreational) sUAS pilots may fly at night under certain conditions, when asked about night flight, the incident pilot only stated that he had built-in position lights; thus he was likely unaware of any guidelines or practices for night operations.

There was no evidence of any mechanical or software problems with the sUAS relevant to the flight. The pilot did not report any anomalies, and stated the recorded information on the flight logs accurately reflected the incident flight. The sUAS operated as expected at all times. Although the recorded data showed a 9-second gap in telemetry, this was likely due to distance from the remote controller.

The National Transportation Safety Board determines the probable cause(s) of this incident to be: The failure of the sUAS pilot to see and avoid the helicopter due to his intentional flight beyond visual line of sight. Contributing to the incident was the sUAS pilot's incomplete knowledge of the regulations and safe operating practices.
