The

Safety

Wire

April 2018

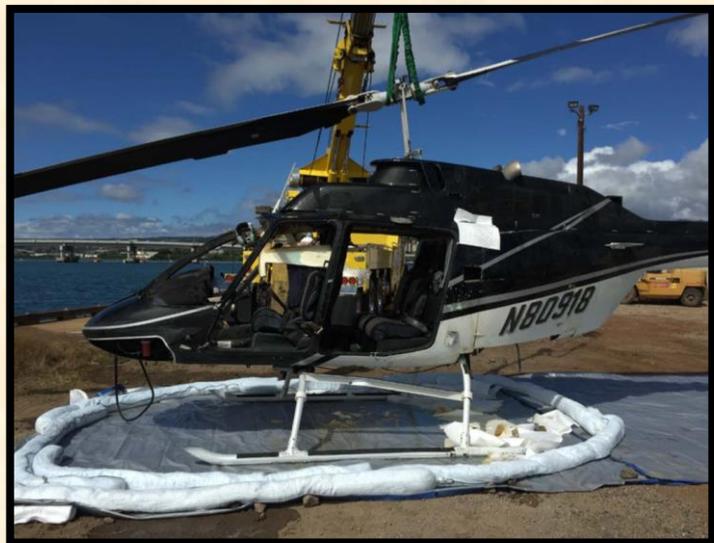
Postaccident examination of the helicopter revealed that the engine-to-transmission drive shaft was separated at the transmission side. Metallurgical examination of the engine-to-transmission drive shaft components revealed that the forward coupling did not appear to be lubricated and that there were multiple indications of exposure to elevated temperature, such as heat tinting and loss of the temperature plates on the forward outer coupling, high-temperature cadmium-induced brittle fracture of two forward attachment bolt heads, and a loss of hardness of the bolt head material due to high-temperature tempering. The external spline teeth on the forward spherical coupling were worn down to the bottom landings, while comparatively minor wear marks were observed on the mating internal spline teeth of the forward outer coupling. The asymmetry in the wear pattern between the spherical coupling and the outer coupling combined with the observations consistent with elevated temperatures indicate that the assembly likely failed by overheating due to lack of lubrication. This resulted in softening and subsequent failure of the spring that limits and centers the spherical coupling. When the spring failed, the coupling shifted

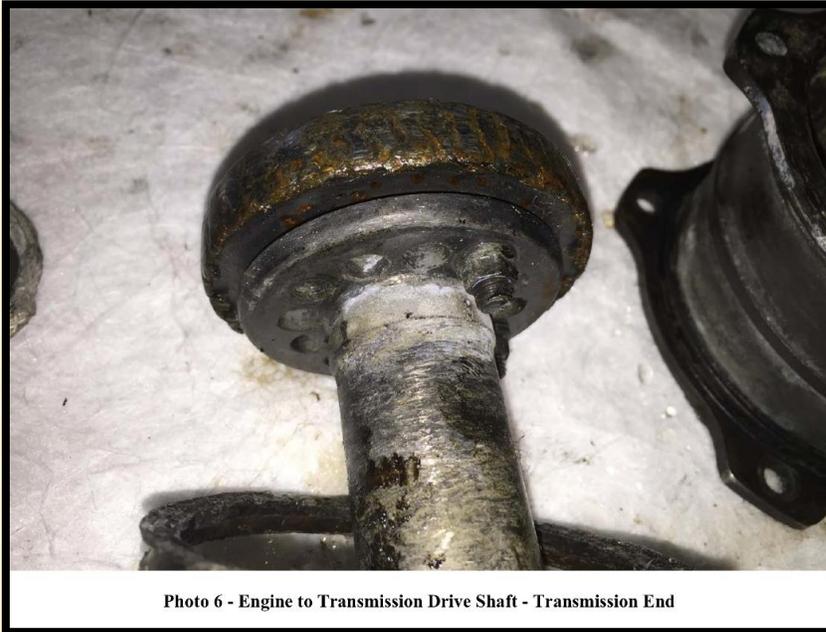
Photo 6 - Engine to Transmission Drive Shaft - Transmission End

forward, damaging the forward end of the outer coupling, fracturing the forward cover plate, and wearing the external spline teeth down to the bottom landings. Following the failure of the drive shaft, the engine would have continued to operate, but would not have been able to drive the main rotor.

The National Transportation Safety Board determines the probable cause(s) of this accident to be: The in-flight failure of the engine-to-transmission drive shaft due to improper maintenance, which resulted in low main rotor rpm and a subsequent hard landing to water.
