**The**

**Safety**

**Wire**

**April 2021**

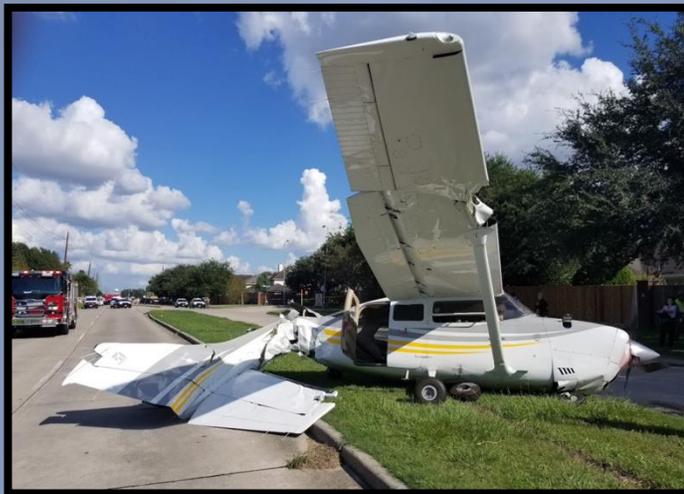
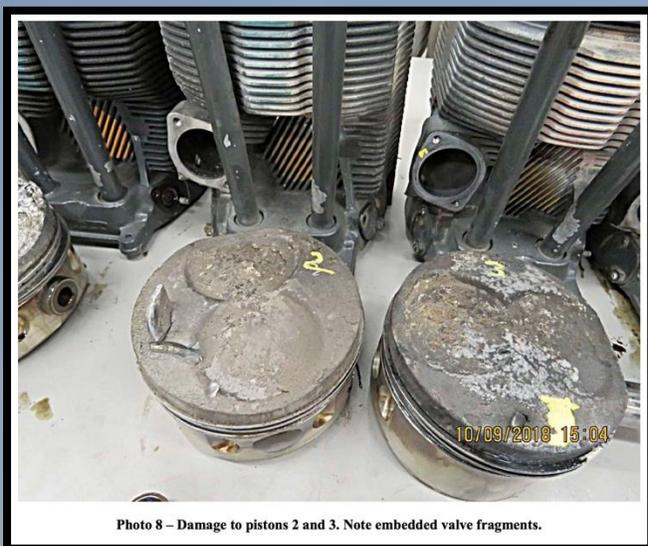
Photo 8 – Damage to pistons 2 and 3. Note embedded valve fragments.

Postaccident engine examination revealed the No. 1 cylinder intake valve had failed. Fractured pieces of the intake valve had been drawn into the intake plenum. The No. 1 cylinder was extensively damaged, and all of the piston heads had impact marks or pieces of valve embedded in the heads. The No. 1 cylinder, No. 1 piston, its intake and exhaust valve train components (springs, pushrods, and rocker arms), and 12 hydraulic lifters were sent to the engine manufacturer for metallurgical examination, which revealed that the No. 1 cylinder intake valve had failed in

fatigue; however, the root cause of the failure could not be determined due to the extensive damage after the valve failure. Both the intake and exhaust rocker arms had nonconforming shoe heights. In addition, nine of the hydraulic lifters failed the leak-down test, including the No. 1 intake. Maintenance information revealed the engine had been overhauled 4 years earlier, during which all 12 hydraulic lifters were replaced. The intake and exhaust rocker arms had been reworked and reused, and about 0.01 inch of

material had been removed from the shoe pads during the overhaul. While the nonconforming rocker arm shoe height and lifter may have contributed to a malfunction of the valve, the investigation could not determine with certainty the reason for the fatigue failure. The fatigue failure of the No. 1 cylinder intake valve resulted in the loss of engine power.
