The

Safety

Wire

August 2018

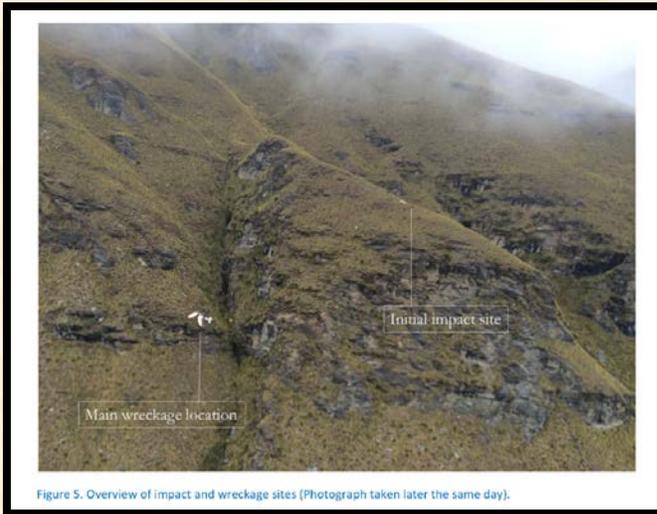
The Civil Aviation Authority (CAA) was notified of the accident at 1343 hours on Monday 16 March 2015 by the Rescue Coordination Centre New Zealand. A pilot flying a helicopter along the Motatapu River North Branch near Wanaka, had spotted the wreckage of an aircraft. The CAA safety investigation found that the aircraft had collided with terrain during a poor visibility reversal turn in the Motatapu River North Branch, 1.3 nautical miles from the saddle at the head of the valley. The impact forces involved during the accident were not survivable.

Figure 5. Overview of impact and wreckage sites (Photograph taken later the same day).

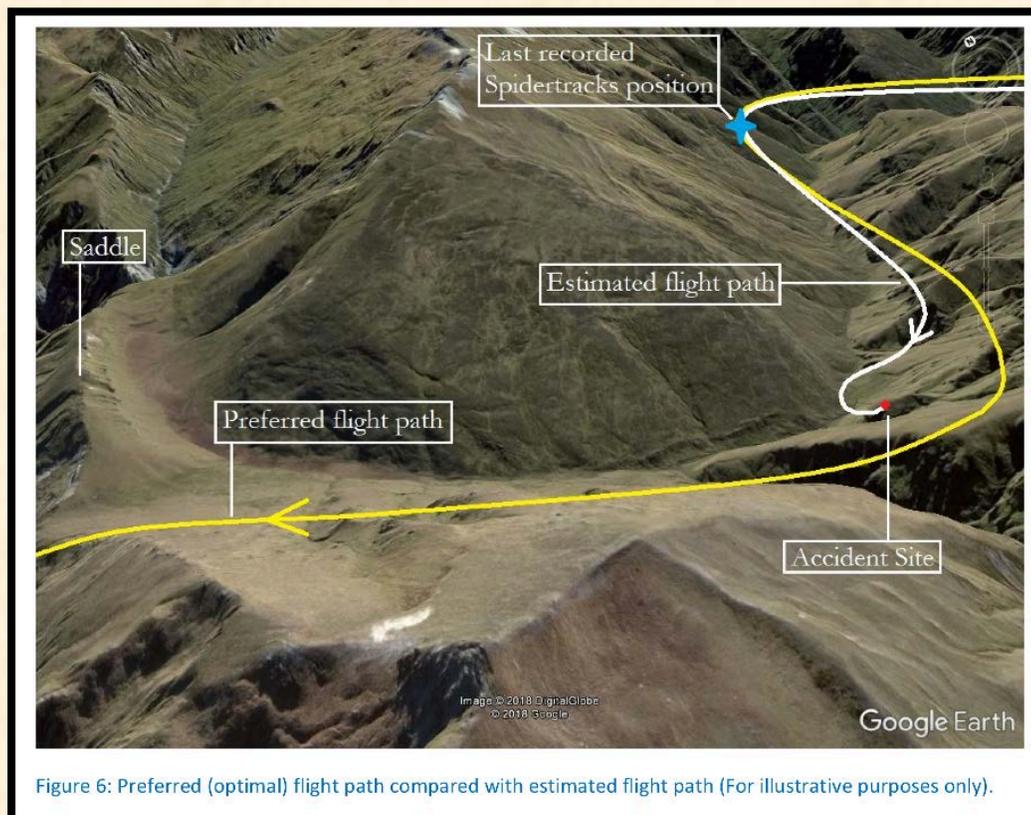
The forecast weather conditions, were not conducive for flight under Visual Flight Rules (VFR) for the intended route to be flown. There was no evidence to suggest that the pilots were subjected to any time pressure to reach the destination.

The CAA safety investigation determined that the actions and decision making by the pilots prior to and during the flight, including the breaching of CAA rules and not following recommended practices, contributed to the accident.

Figure 6: Preferred (optimal) flight path compared with estimated flight path (For illustrative purposes only).
