Safety

Wire

September 2017

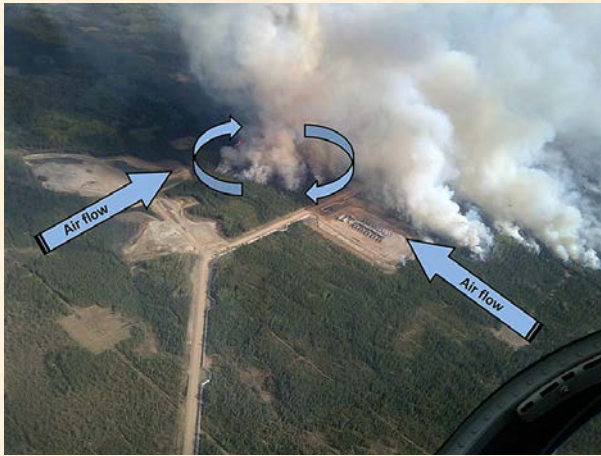
Fire whirls are tornadic events generated by a fire. On a small scale, they are similar to dust devils; on a large scale, they are more like tornadoes generated by a thunderstorm. There are several documented examples of this phenomenon. In June 2002 near Durango, Colorado, the Mission Ridge fire generated a large rotating vertical plume with winds strong enough to overturn vehicles and damage structures. The Neola North fire near

Neola, Utah, generated cyclonic winds that caused the death of 3 people on 29 June 2007. On 18 January 2003 in Canberra, Australia, a large bush fire spawned a fire whirl on the scale of a tornado. It created a damage path 25 km long and, in some areas, 500 m wide. Trees were uprooted, vehicles were overturned, and roofs were ripped from houses. The winds were estimated at 250 km per hour, which equates to a strong F2 on the Fujita scale.

Immediately after the accident, a large fire whirl was seen moving from southeast to northwest across the borrow pit west of T692. The fire whirl was approximately 50–100 feet wide at the base and extended to an altitude of approximately 1500 feet agl. It had a very strong rotation and uptake of material. The fire whirl continued across the borrow pit and re-entered the treeline, where another fire was ignited by debris it was carrying. It then disappeared from view shortly after entering the trees.

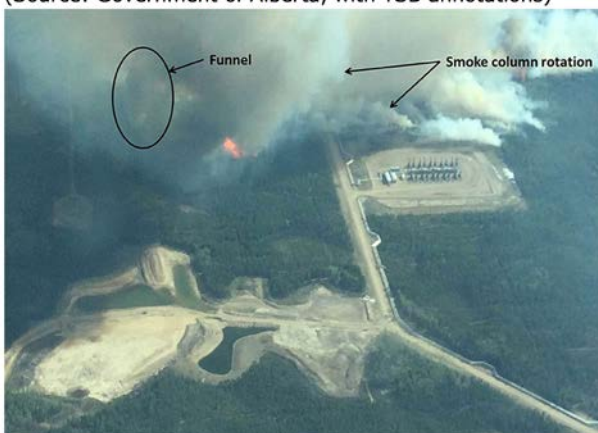
**Figure 6.** The smoke column, showing evidence of plume shedding, with a funnel developing in the smoke, at 1629:53, approximately 1 minute before the accident (Source: Government of Alberta, with TSB annotations)
