The

Safety

Wire

October 2017

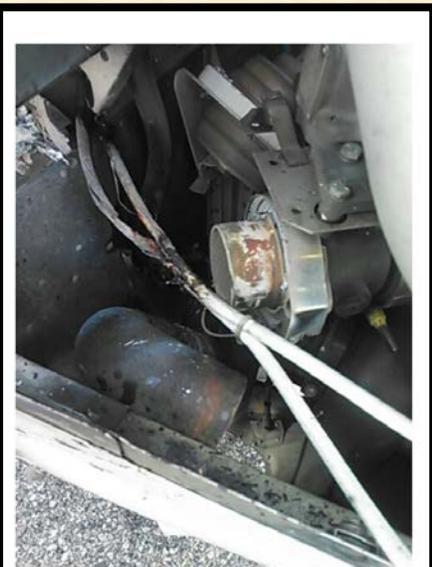
Photo 2 - Separated Tailpipe

Examination revealed that the airplane experienced an in-flight fire due to the separation of the engine's turbocharger wastegate overboard exhaust tailpipe from the turbocharger housing. The hot gases from the exhaust system subsequently burned through the battery's electrical cable insulation, which resulted in arcing, a short circuit, and fire. The airplane manufacturer had issued a service bulletin (SB) 16 years before the incident, which recommended installing a tailpipe lanyard to prevent the separation of the tailpipe.

About 6 months before the incident, the airplane experienced a similar separation of the tailpipe. The damage was less severe, and it was limited to the battery and its electrical cables. After that event, the tailpipe clamp and gaskets were replaced, but the owner did not comply with the SB. No lanyard was found on the airplane, and no record was found indicating that the owner had complied with the SB at any time. However, the airplane was operating under the provisions of 14 Code of Federal Regulations Part 91; therefore, compliance with the SB was not mandatory. Although complying with the SB was not mandatory for this airplane's operations, the owner should have complied with the SB to ensure the continued safe operation of the airplane.

The National Transportation Safety Board determines the probable cause(s) of this incident to be: An in-flight fire during initial climb due to the separation of the engine's turbocharger wastegate overboard exhaust tailpipe. Contributing to the accident was the owner's decision to not comply with a service bulletin that addressed the tailpipe separation.
