The

Safety

Wire

November 2016

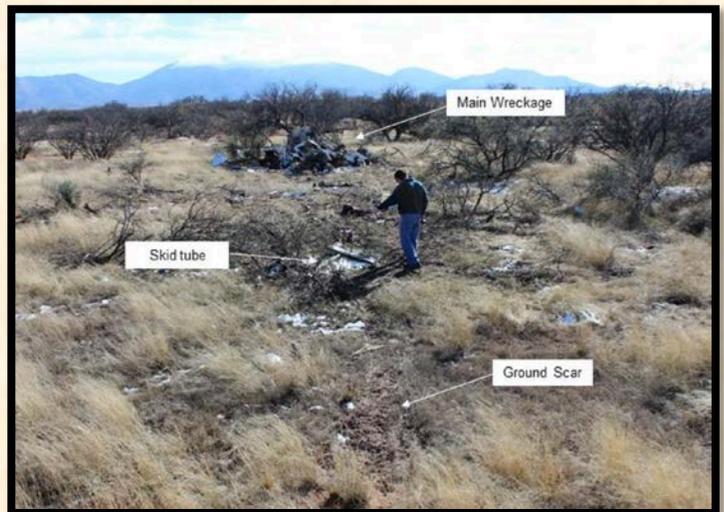
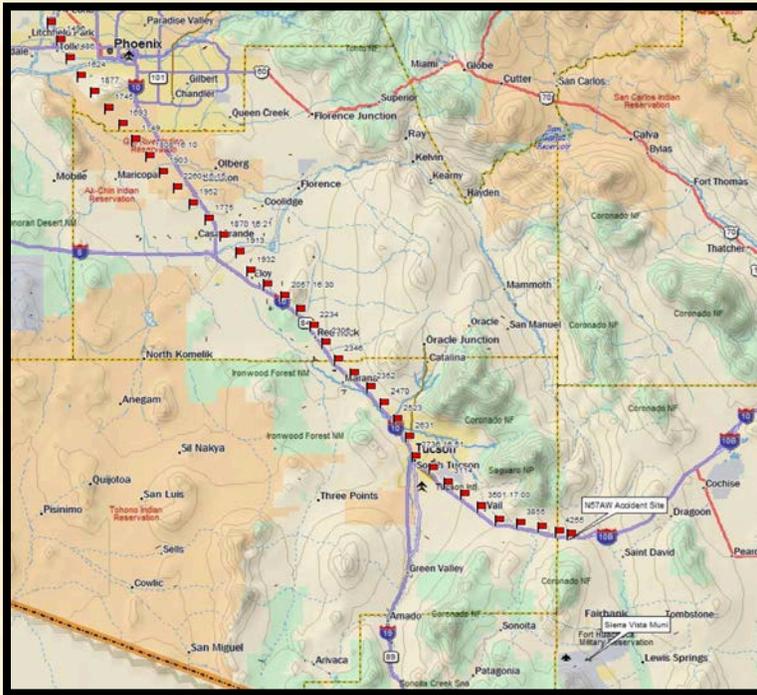
On December 31st, 2014, the helicopter was on a visual flight rules (VFR) repositioning flight in preparation for providing contracted air support capability to the local sheriff's office the next day. The operator reported that the helicopter did not arrive at the intended destination, and the wreckage was located 29 miles north of the intended destination. The helicopter was fragmented into multiple pieces along a 174-ft debris path. Ground scars and wreckage distribution were consistent with collision with terrain while in forward flight. The observations from a weather station located 3 miles east-southeast of the accident site indicated ceilings less than 500ft and visibility less than 1 mile were likely at the time of the accident. The relative humidity had rapidly increased above 90 percent immediately before the accident, which would be indicative of cloud cover and mist at or near the surface. Witnesses living in the local area reported that the visibility at ground level was very limited, with low clouds and fog. Observations near the destination showed lowered visibility and low ceilings as the rain moved eastward through the accident area. Gusty winds ahead of the lowering ceilings would have likely created low-level wind shear.

The operator's flight data monitoring system indicated that the helicopter was flying along an interstate about 300ft above ground level (AGL), which decreased to about 200ft AGL, likely as the visibility was reduced. However, the last recorded points indicated that the helicopter had climbed to about 500ft AGL, and was no longer tracking the interstate. It is likely that the VFR flight encountered instrument meteorological conditions, and the pilot was trying to maneuver to an area with greater visibility when the helicopter collided with terrain.

The National Transportation Safety Board determines the probable cause(s) of this accident as follows: The pilot's continued visual flight into instrument meteorological conditions, which resulted in an inflight collision with terrain. Contributing to the accident was the pilot's inadequate preflight planning, during which he failed to identify forecasted deteriorating weather conditions along the route of flight.
