**The**

**Safety**

**Wire**

**January 2021**

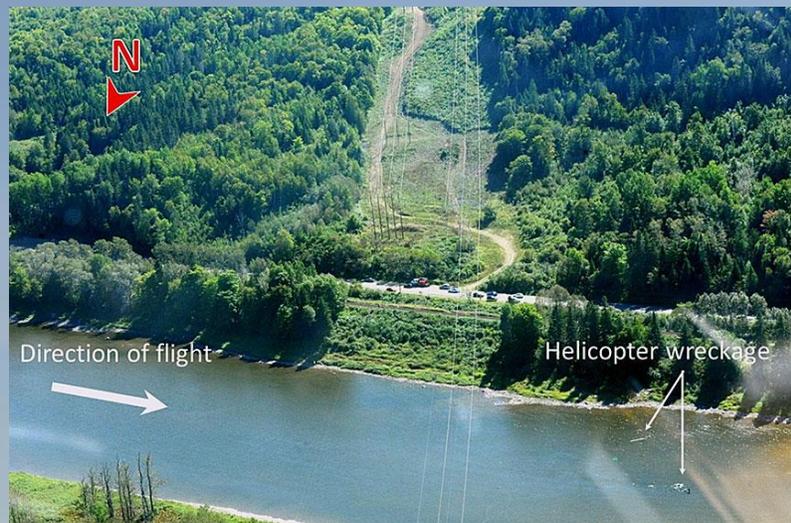
At 1547, the helicopter flew into and severed 4 conductor cables of the 230 kV power transmission lines at 58 feet above the Restigouche River on the south side of Long Island. The helicopter was not equipped with a wire strike protection system.

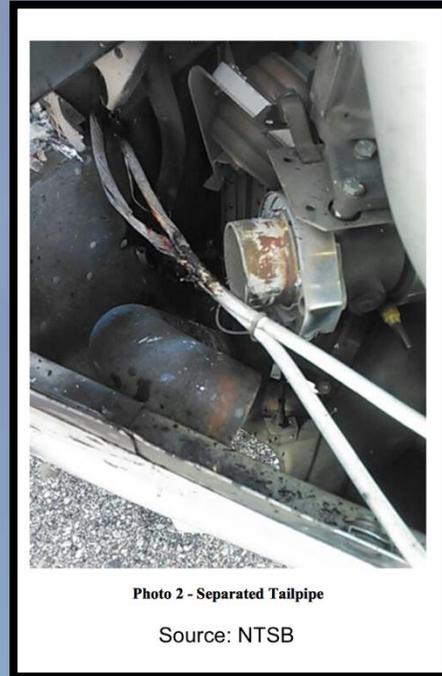
Examination revealed that the airplane experienced an in-flight fire due to the separation of the engine's turbocharger wastegate overboard exhaust tailpipe from the turbocharger housing. The hot gases from the exhaust system subsequently burned through the battery's electrical cable insulation, which resulted in arcing, a short circuit, and fire. The airplane manufacturer had issued a service bulletin (SB) 16 years before the incident, which recommended installing a tailpipe lanyard to prevent the separation of the tailpipe.

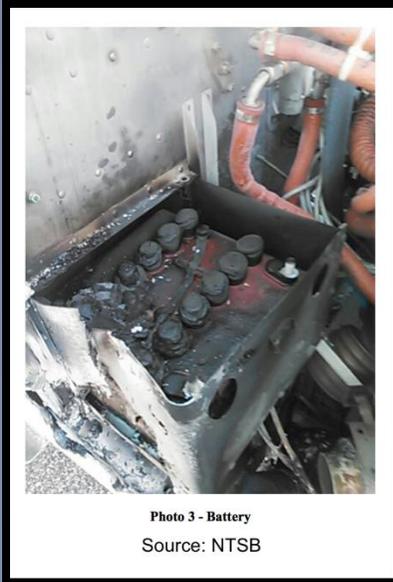
Photo 3 - Battery  
Source: NTSB

About 6 months before the incident, the airplane experienced a similar separation of the tailpipe. The damage was less severe, and it was limited to the battery and its electrical cables. After that event, the tailpipe clamp and gaskets were replaced, but the owner did not comply with the SB. No lanyard was found on the airplane, and no record was found indicating that the owner had complied with the SB at any time. However, the airplane was operating under the provisions of 14 Code of Federal Regulations Part 91; therefore, compliance with the SB was not mandatory. Although complying with the SB was not mandatory for this airplane's operations, the owner should have complied with the SB to ensure the continued safe operation of the airplane.
