The

Safety

Wire

January 2014

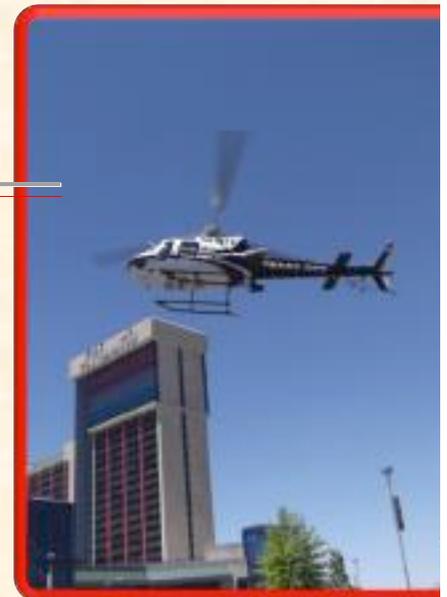
A Eurocopter EC 130 landed hard during an autorotation while on short final. The commercial pilot was the sole person on board and was not injured. The helicopter came to rest on its right side and sustained substantial damage to the fuselage and tail boom.

The pilot reported that she completed the **post-maintenance operational check flight** and was on short final, about 200 feet above the ground with an airspeed of 40 to 50 knots. Shortly thereafter, the fuel pressure indicator light illuminated and the engine "flamed out". The pilot stated that she lowered the collective to initiate an autorotation, **but did not have the airspeed to successfully complete it.**

The helicopter's tailboom impacted the ground first during the accident sequence, followed by the hard landing. The helicopter's skids separated and the fuselage sustained substantial damage.
