## AIRBORNE PUBLIC SAFETY ASSOCIATION

The

Safety

Wire

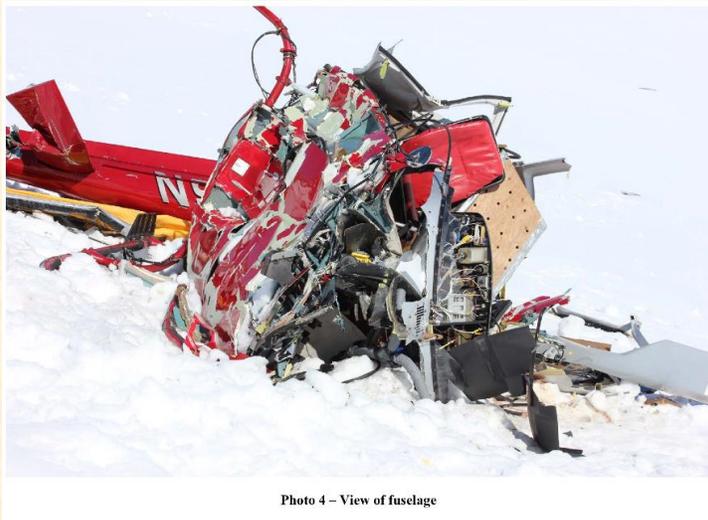
Photo 4 – View of fuselage

The non-instrument-rated commercial pilot was making a visual flight rules internal-cargo company flight in the helicopter. He was returning to base in the helicopter [from] a remote dog camp situated on a glacier surrounded by mountainous terrain. The pilot had previously completed 5 of the day's 7 planned roundtrip flights from the base to the dog camp. According to the dog camp manager, the weather was deteriorating with snow and wind increasing when the pilot departed on the accident flight. The dog camp manager's observations and radar data indicated that the pilot attempted to depart via the normal route to the south but turned around. He likely encountered low visibility conditions and then attempted several departures by routes to the north of the dog camp. About 8 minutes after departure, the helicopter impacted snow-covered mountainous terrain about 2 miles northeast of the dog camp.

During the impact sequence, the two cargo straps used to secure two wooden dog boxes to the rear cabin floor failed, and the dog boxes shifted forward, striking the back of the pilot's fiberglass seat.

The pilot's decision to continue visual flight into an area of instrument meteorological conditions, which resulted in the pilot experiencing a loss of visual reference and subsequent controlled flight into terrain. Contributing to the accident were the pilot's self-induced pressure to complete the flight and the operator's failure to maintain operational control over the flight.
